# Assessment of the Effect of Underground Water on Civil Engineering Structures (A Case Study of Gaa-Odota, Ilorin)

K.O. Olorunfemi, E. O. Ibiwoye and D.J. Adeleke.  
Department of Civil Engineering, Institute of Technology  
Kwara State Polytechnic, P.M.B 1375, Ilorin, Kwara State, Nigeria  
*E-mail: olorunfemikenny@gmail.com*

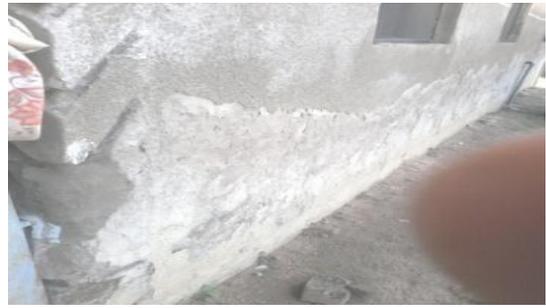
Fig. 2: Efflorescence on building at Gaa-Odota, Ilorin.

- (i) Efflorescence: Is a whitish deposit on surface of masonry, wall and concrete. Efflorescence is a major problem found on many buildings in the study area. It consists of gypsum, salt or calcite. It is formed as mineral water rises to the surface through capillary and then evaporates as shown in Fig. 2.
- (ii) Mold growth: As underground water rises during rainy season, it penetrated into the block wall which led to mold growth on block wall and gradually weaken block walls as shown in Fig. 3.

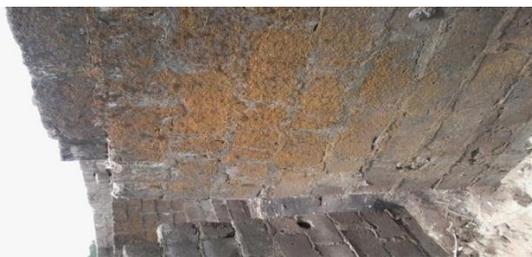
Fig. 3: Mold growth on building at Gaa-Odota, Ilorin

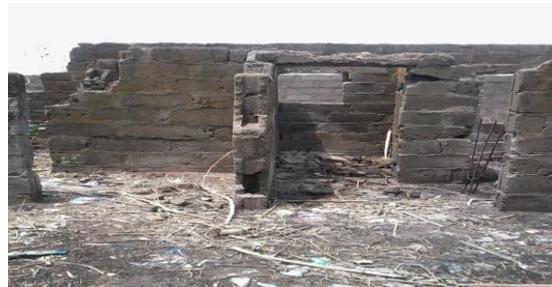
Fig. 4: Partial collapse of building at Gaa-Odota, Ilorin.

- (iii) Partial collapse of building: Penetration of water from underground to building structure at Gaa-Odota led to partial collapse of building as shown in Fig.4.
- (iv) Paint peeling: Peeling of paint is caused by the presence of damp through underground water as shown in Fig. 5.

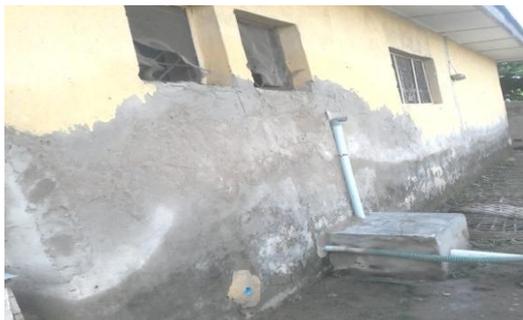
Fig. 5: Paint peeling on building at Gaa-Odota, Ilorin.

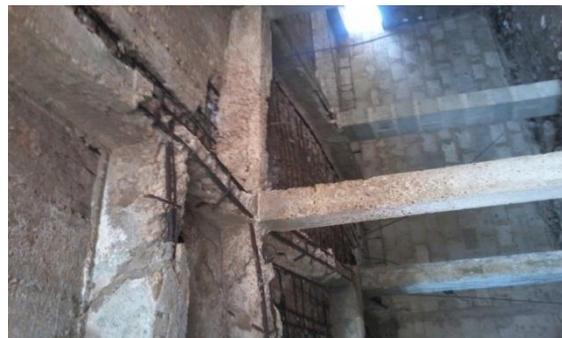
Fig. 6: Disintegration of reinforced concrete slab at Gaa-Odota Ilorin.

- (v) Disintegration of reinforced concrete slab: Disintegration of concrete at Gaa-Odota occurred as a result of freeze cycles on surface moisture which is caused by too much of water and the concrete pores then expand. The expansion of concrete forces off the concrete surface as shown in plate Fig. 6.
- (vi) Cracks: Water movement from underground water to the foundation of building causes cracks in building at Gaa-Odota. This movement are cyclic in nature and are caused by increase or decrease in inter pore pressure with moisture change when underground water rise through capillary action as shown in Fig. 7.

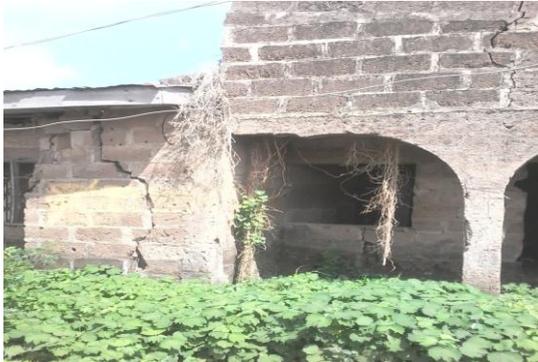
Fig. 7: Cracks on building at Gaa-Odota , Ilorin

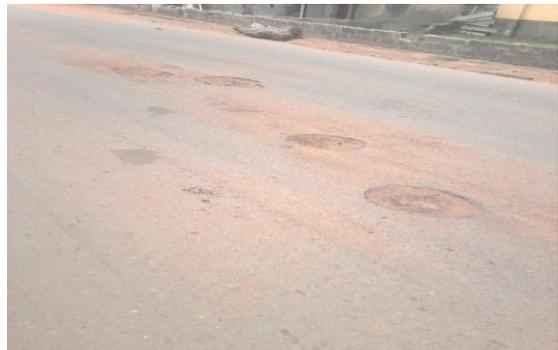
Fig. 8: Potholes on road pavement at Gaa-Odota, Ilorin

- (i) Potholes: This is a small, bowl shaped depression in pavement surface that penetrate all way through the asphalt layer down to the base course. They have sharps edge and vertical sides near the top of the hole. Potholes in this area was caused by moisture infiltration from underground water as shown in Fig. 8.
- (ii) Edge cracks on road pavement: Edge cracks travel along the inside edge of the pavement surface within one or two feet. The cause of these cracks on road pavement at Gaa-Odota is poor drainage system as shown in Fig. 9.

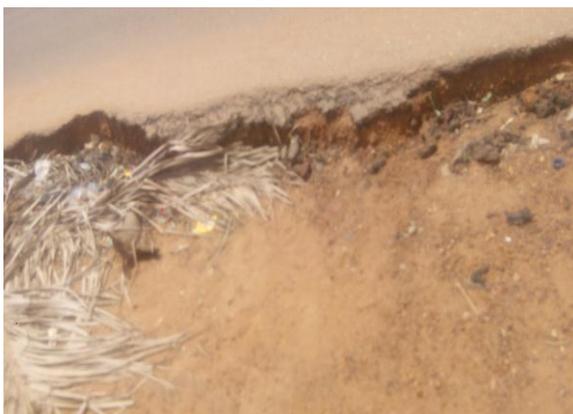
Fig. 9: Edge crack on road pavement at Gaa-Odota, Ilorin

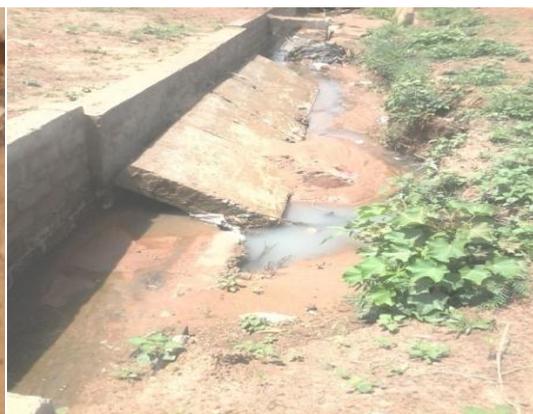
Fig. 10: Lined drainage collapse at Gaa-Odota, Ilorin.

- (i) Lined Drainage Collapse: Lined drainage collapse at Gaa-Odota was as a result of excessive pressure of water in the ground beneath and beside drain lining as shown in Fig. 10.

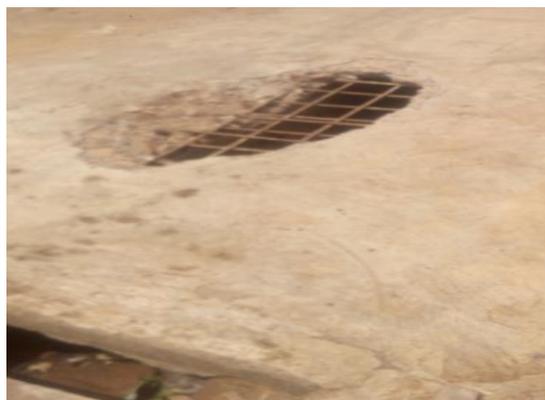
- (ii) Failure of road culvert: Culvert is a structure that allows water to flow under a road, railroad and trail. Failure of culverts in Gaa-Odota is due to upsurge of water through capillary action which led to corrosion of reinforcement and later breaks the concrete as shown in Fig.11.

Fig. 11: Failure of road culvert at Gaa-Odota, Ilorin.
